FOD Simulation on Ceramic Gas Turbine Blade

YOSHIDA Hiro

National Institute of Advanced Industrial Science and Technology

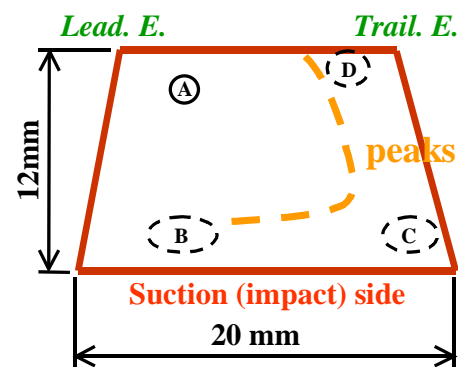
The blade shape and the location of the maximum principal stress are shown in Fig.1. In Fig.1a and b, A denotes the impact point on the suction and the pressure sides of the blade, respectively. The particle impacts on the suction side.

It is found that impact at the upper leading edge generates several stress peaks in the trailing edge area and root of the blade. Those peak locations qualitatively well correspond to the fracture behavior observed in the particle impact experiments. The numerical results supported the possibility that impact at upper leading edge of the blade caused falling off of a part of the trailing edge and failure at the blade root.

Fig.1a Peak stresses on the suction side.

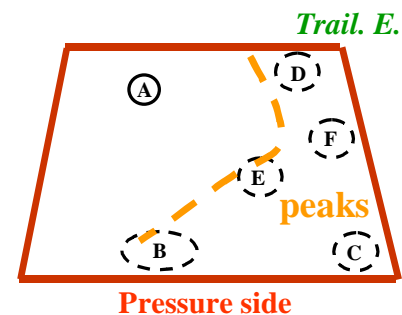
Fig.1b Peak stresses on the pressure side.
B,C,D,E,F: positions of local peak tensile stress
